**VICINITY MAP
SURVEY NOTES**

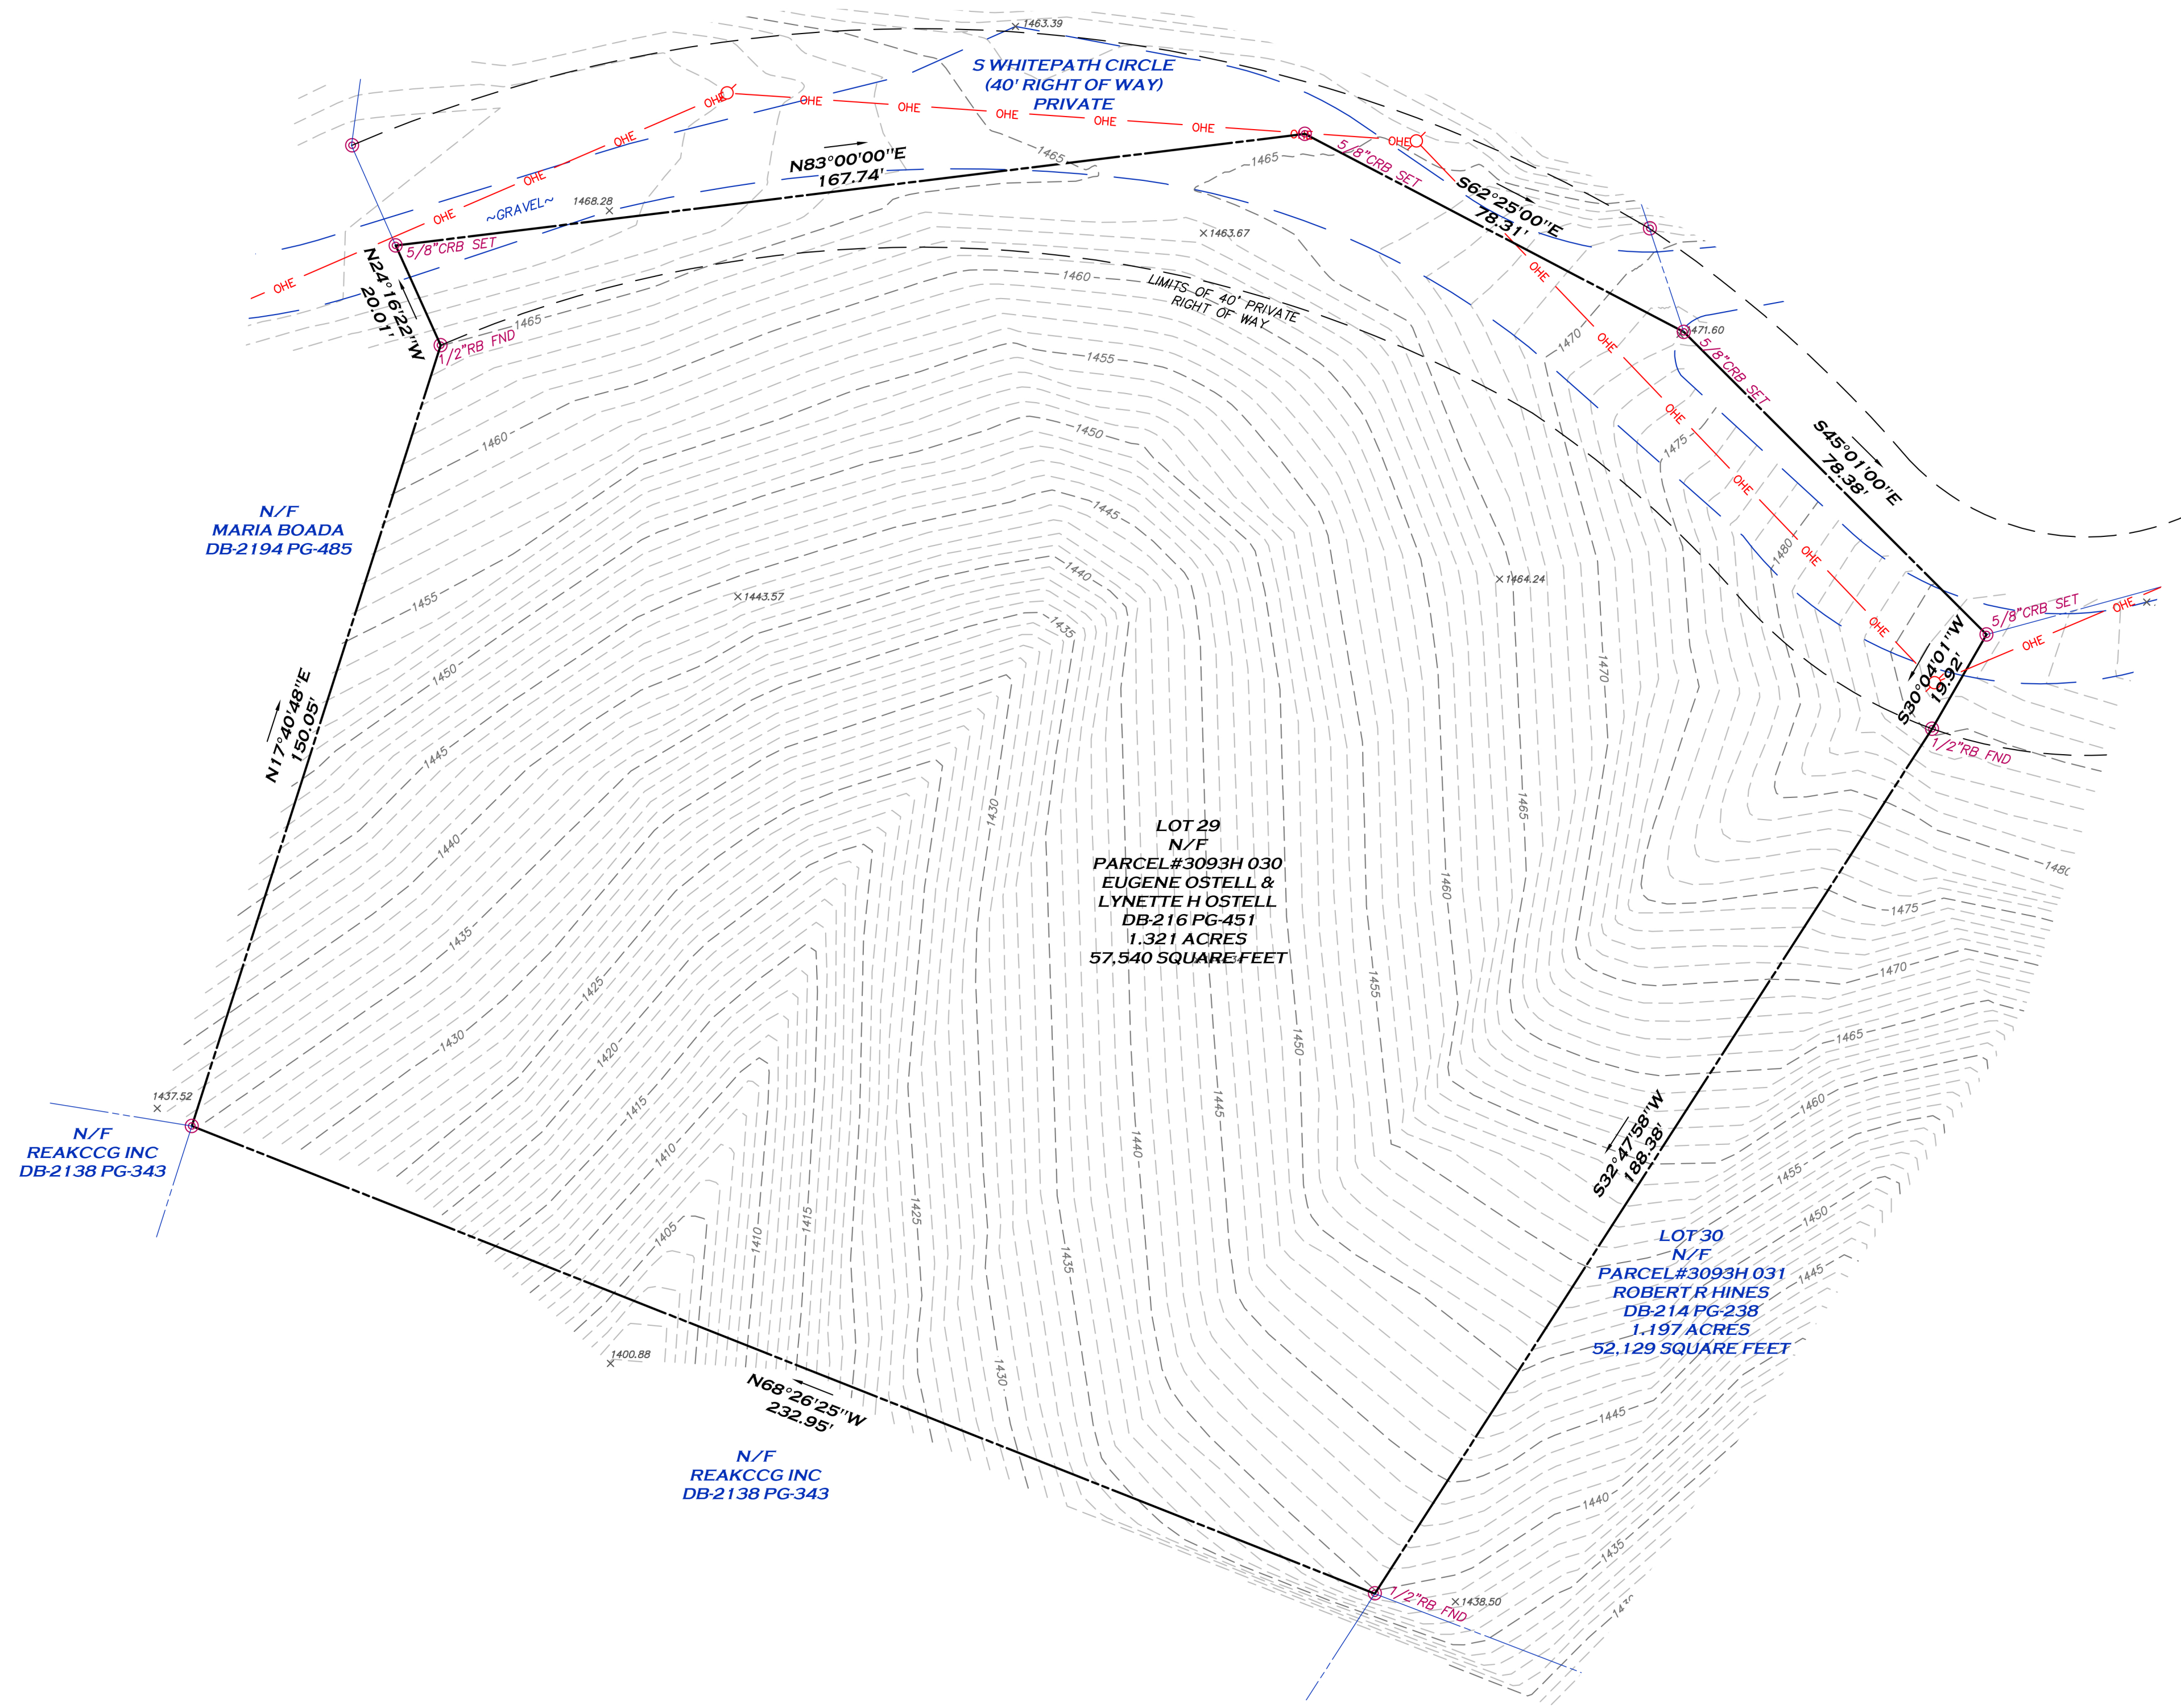
- 1) PROPERTY SHOWN HEREON WAS SURVEYED APRIL 20, 2022.
- 2) THE FIELD DATA UPON WHICH THIS PLAT IS BASED HAS A CLOSURE OF 1" IN 43,264' WITH AN ANGULAR ERROR OF 3.2 SECONDS PER ANGLE POINT AND WAS ADJUSTED USING THE LEAST SQUARES METHOD.

- 5) SAID DESCRIBED PROPERTY IS LOCATED WITHIN AN AREA HAVING A ZONE DESIGNATION X ON FLOOD INSURANCE RATE MAP NO. 13123C0160D, WITH A DATE OF IDENTIFICATION OF APRIL 17, 2012 FOR COMMUNITY NUMBER 130317, IN GILMER COUNTY, STATE OF GEORGIA, WHICH IS THE CURRENT FLOOD INSURANCE RATE MAP FOR THE COMMUNITY IN WHICH SAID PROPERTY IS SITUATED.

- 10) NO ENCROACHMENTS OTHER THAN THOSE SHOWN HEREON WERE OBSERVABLE AT TIME OF SURVEY.
- 11) AT THE TIME OF THE SURVEY, THERE WAS NO OBSERVABLE EVIDENCE OF EARTH MOVING WORK, BUILDING CONSTRUCTION OR BUILDING ADDITIONS.

- 14) SUBJECT PROPERTY HAS DIRECT ACCESS TO SOUTH WHITEPASS CIRCLE, BEING A PUBLICLY DEDICATED RIGHT OF WAY.
- 15) SUBJECT PROPERTY IS CONTIGUOUS TO ALL ADJACENT PROPERTIES AND RIGHTS OF WAY. NO GAPS, GORES, OR OVERLAPS ARE KNOWN TO EXIST.
