VICINITY MAP
SURVEY NOTES

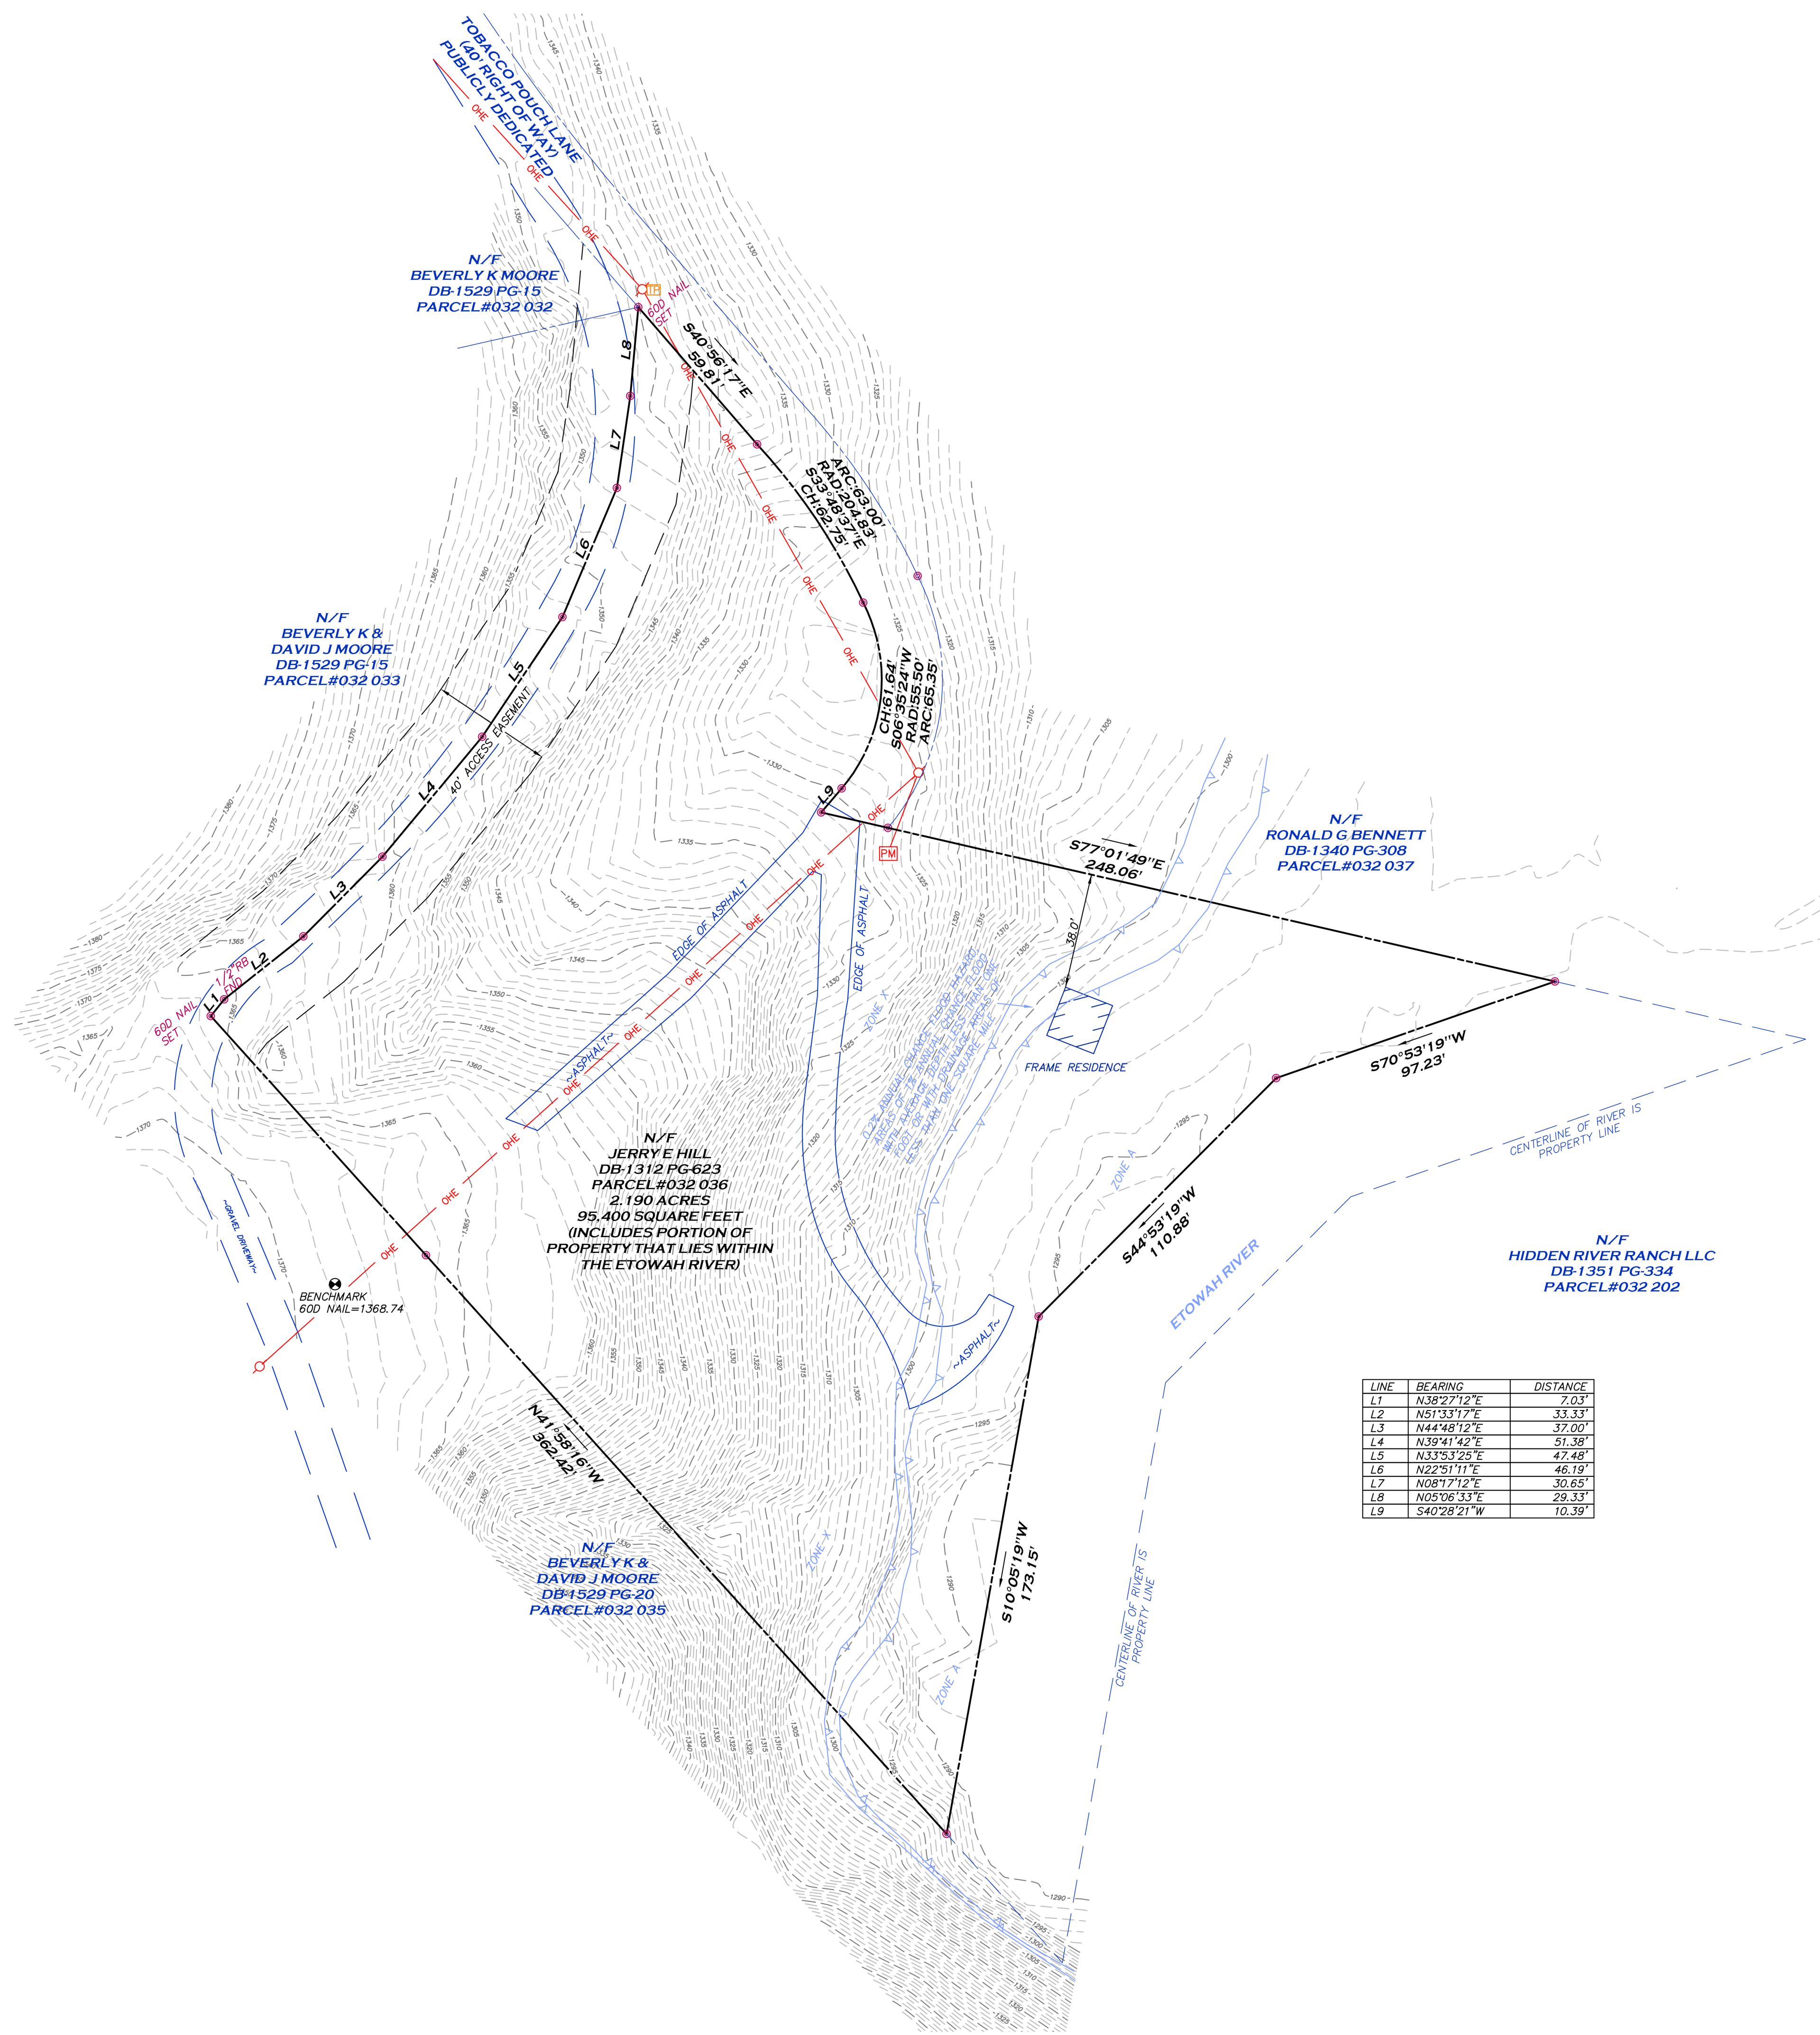
- 1) PROPERTY SHOWN HEREON WAS SURVEYED JUNE 24, 2022.
- 2) THE FIELD DATA UPON WHICH THIS PLAT IS BASED HAS A CLOSURE OF 1" IN 33,168" WITH AN ANGULAR ERROR OF 3.4 SECONDS PER ANGLE POINT AND WAS ADJUSTED USING THE LEAST SQUARES METHOD.

- 4) THIS PLAT HAS A MAP CLOSURE OF 1" IN 246,704'.
- 5) SAID DESCRIBED PROPERTY IS LOCATED WITHIN AN AREA HAVING A ZONE DESIGNATION X AND A FLOOD INSURANCE RATE MAP NO. 13187C01400, WITH A DATE OF IDENTIFICATION OF APRIL 4, 2018 FOR COMMUNITY NUMBER 130354, IN LUMPKIN COUNTY, STATE OF GEORGIA, WHICH IS THE CURRENT FLOOD INSURANCE RATE MAP FOR THE COMMUNITY IN WHICH SAID PROPERTY IS SITUATED.

- 8) NO OBSERVED EVIDENCE OF CEMETERIES, GRAVESITES, AND/OR BURIAL GROUNDS AT TIME OF SURVEY.
- 9) PROPERTY SHOWN HEREON LIES WITHIN THE RECORD DESCRIPTION AS STATED IN GENERAL WARRANTY DEED RECORDED IN DEED BOOK 1312, PAGE 623, LUMPKIN COUNTY RECORDS.

- 10) NO ENCROACHMENTS OTHER THAN THOSE SHOWN HEREON WERE OBSERVABLE AT TIME OF SURVEY.
- 11) AT THE TIME OF THE SURVEY, THERE WAS NO OBSERVABLE EVIDENCE OF EARTH MOVING WORK, BUILDING CONSTRUCTION OR BUILDING ADDITIONS.

- 12) AT THE TIME OF THE SURVEY THERE WERE NO PROPOSED CHANGES IN STREET RIGHT OF WAY LINES OR OBSERVABLE EVIDENCE OF STREET OR SIDEWALK REPAIRS.
- 13) AT THE TIME OF THE SURVEY, THERE WAS NO OBSERVABLE EVIDENCE OF THE SITE BEING USED AS A SOLID WASTE DUMP, SUMP OR SANITARY LANDFILL.

- 14) SUBJECT PROPERTY HAS DIRECT ACCESS TO TOBACCO POUCH LANE, BEING A PUBLICLY DEDICATED RIGHT OF WAY.
- 15) SUBJECT PROPERTY IS CONTIGUOUS TO ALL ADJACENT PROPERTIES AND RIGHTS OF WAY. NO GAPS, GORES, OR OVERLAPS ARE KNOWN TO EXIST.
